Journal of Science and Technology

January 2013

Documentation on Five Colonial Buildings of Panam Nagar: Structure, Material, Decoration and Ornamentation

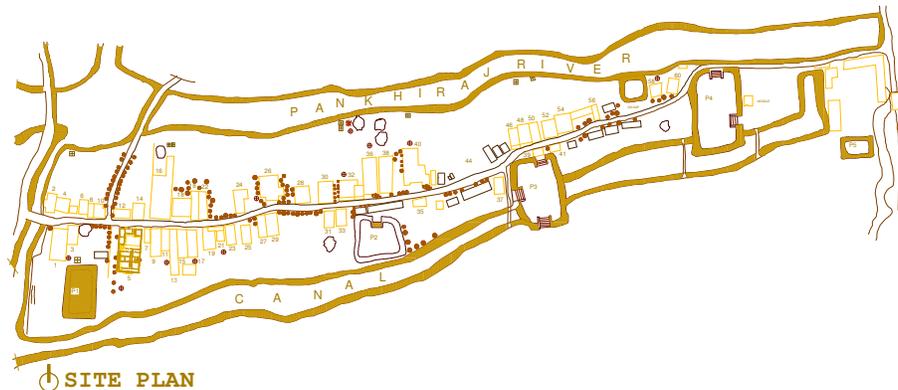
Figure-03: The Existing Master Plan of Panam showing the sixty buildings.
(Source: Field Study, 2006).

Panam Nagar locality is highly dense with single to three storied attached and detached houses of varying types and sizes. The number of the houses which were erected in the Panam area is counted presently at sixty on both the side of the Panam Street (Fig-03).

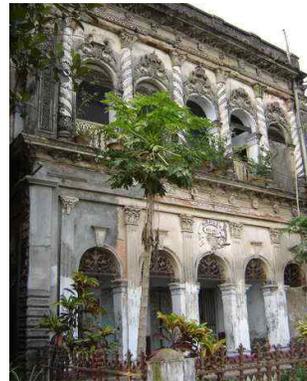
Figure-04: The front view of Building no. 38 known as Kashinath Bhaban.

This unique two-storied colonial building is known as Kashinath Bhaban. This building is an exceptional example of the central courtyard type building where on end of the court is lined with the boundary wall. The facade of this building is perfectly expressed the desire for simplicity among ornately decorated work.

plastered in building no. 38 (Fig-04), 31 (Fig-07) and 42 (Fig-08) or left exposed for facade delineation in building no. 40 (Fig-05) and 01 (Fig-06). Angular brick masonry has been used in the area between the spring point and the crown of the arch, most probably for structural reasons. In these buildings the thickness of brick masonry walls varies between 50 to 70 cm. Primarily for bonding lime mortar have been used in these buildings. Roof stands on rafter and purlin made of wood especially in building no. 31 (Fig-15.h). Hut-shaped *do-chala* rooftop covered the small rooms, used in building no. 42. Plaster decoration have been extensively applied in facade design and interior decoration, extensively used in building no. 38. Cast iron brackets, ventilators, window grills, balusters had been extensively used in these buildings, especially used in building no. 31 (Fig-15.i). Colored glass and glazed tiles were applied for decoration in the entrance verandah of the building no. 31 (Fig-15.g) and 38. Decoration with broken china locally known as *chinitikri* work was very popular in interior decoration especially used in building no. 38 (Fig-10) and modest exterior application is also found in these selected five colonial buildings.

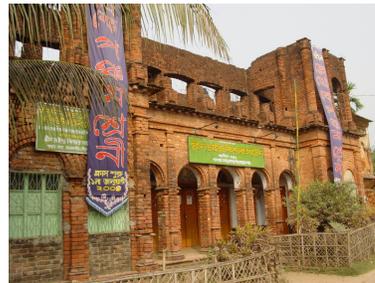
Figure-05: The front view of Building no. 40.

This colonial building is named as Green Child Kinder Garden. The building is two storied, while only a broken facade of the upper floor with no roof is standing. This building is a true example of a central courtyard type building.

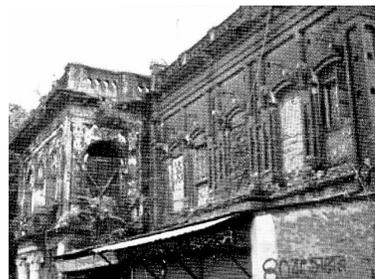
Figure-06: The front view of Building no. 01.

This colonial building of Panam Nagar, located at the right side of the street immediately after the entrance to the area. In the double height central hall room on the ground of the two-storied building, there is a *bedi* or raised platform built-in at the northern side for sitting.

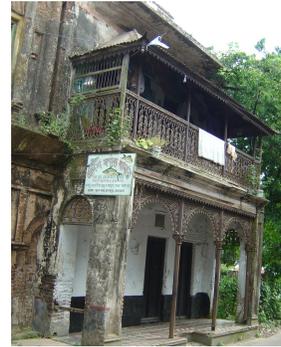
Figure-07: The front view of Building no. 31.
(Source: Field Study, 2006).

This building located at the south side of the street. Construction period of this building was 1928 AD, which one possibly is the last building built on the Panam Nagar street. This two storied consolidated type building is more responsive to tropical climate as transparent front verandahs give the impression of an extrovert house.

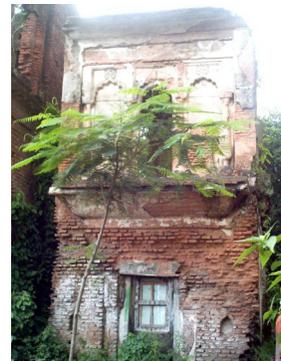
Figure-08: The front view of Building no. 42.
(Source: Field Study, 2006).

This two-storied multiple compartment type building is located at the north side of the street. This colonial building style shows remarkable Mughal architectural decorative features. Thus this building was probably built in the late Mughal mid eighteenth century.

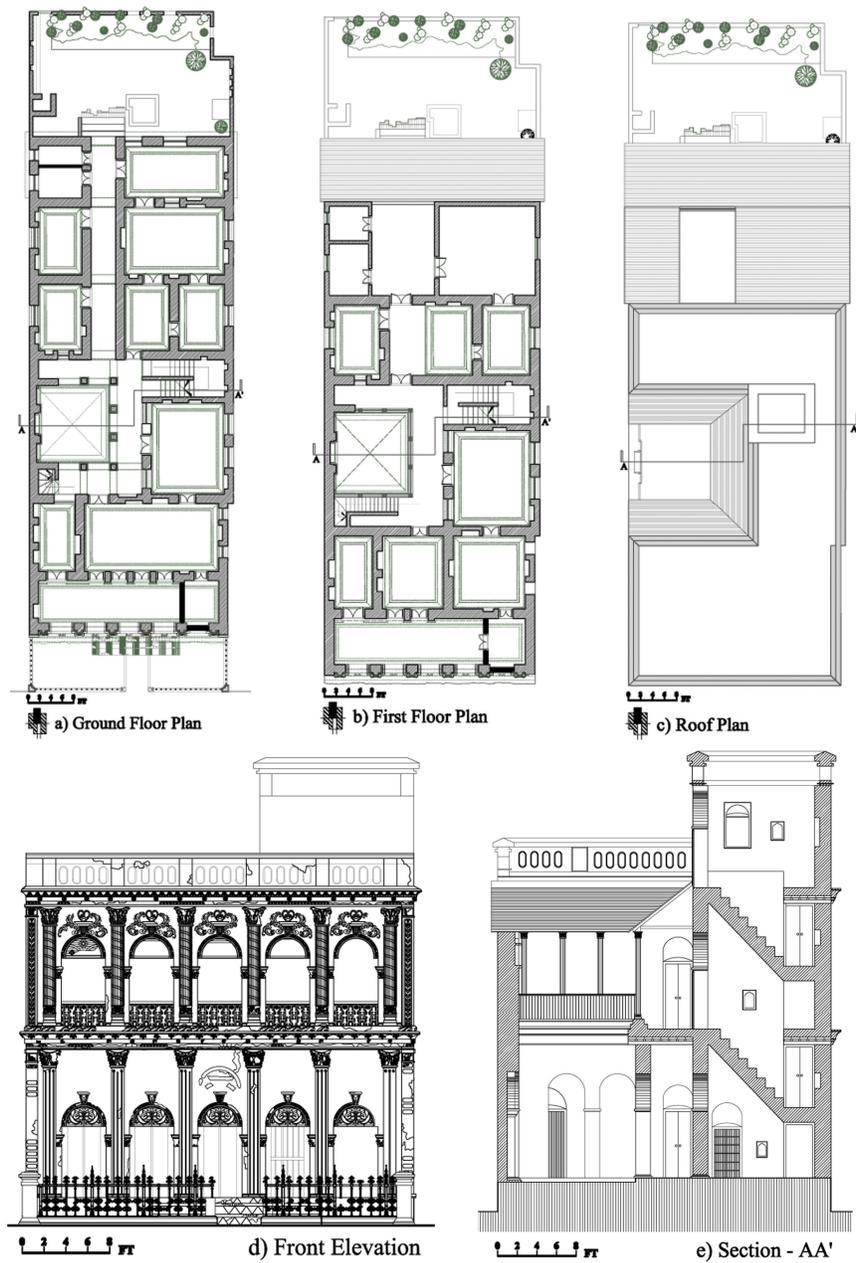
Figure-09: a) Ground Floor Plan, b) First Floor Plan, c) Roof Plan, d) Front Elevation with decorative exterior facade, and e) Section-AA' of the Building no. - 38.

| Characteristics of the building | View or Image | Description |
|---|---|---|
| 1. Building type | Fig-9,10 a,b,c,g,h | This is a courtyard type building; where on end of the court is lined with the boundary wall. |
| 2. Building layout | Fig-09. a, b, c | Rectangular in shape and elongated in the north-south direction. The width and length of the building facade is approximately 10.7m and 37m respectively. |
| 3. Structure and Materials | Fig-09, Fig-10 | Bricks are plastered for facade delineation. Cast iron brackets, ventilators, window grills, railings, balusters had been extensively used. Ornamentation was made by lime <i>surki</i> and plaster. Decoration with <i>chinitikri</i> work has been done in the columns of the front facade. |

| 4. Architectural Decoration and Ornamentation | Fig-09, Fig-10 | The facade was articulated by round columns with Corinthian capital (upper floor) and Corinthian pilaster (ground floor), flanking five openings at each level. The upper floor columns have <i>chinitikri</i> decoration consisting of dark color spiral band in a distinct pattern. Corner of the building is emphasized with decorative floral treatment. Cast iron arch openings, railings, key-stones, column capital, base etc. have been thoroughly decorated. |
| 5. Entrance | Fig-09.d Fig-10.g | The entry is well emphasized with extremely decorative exterior front facade through a raised plinth and verandah. |

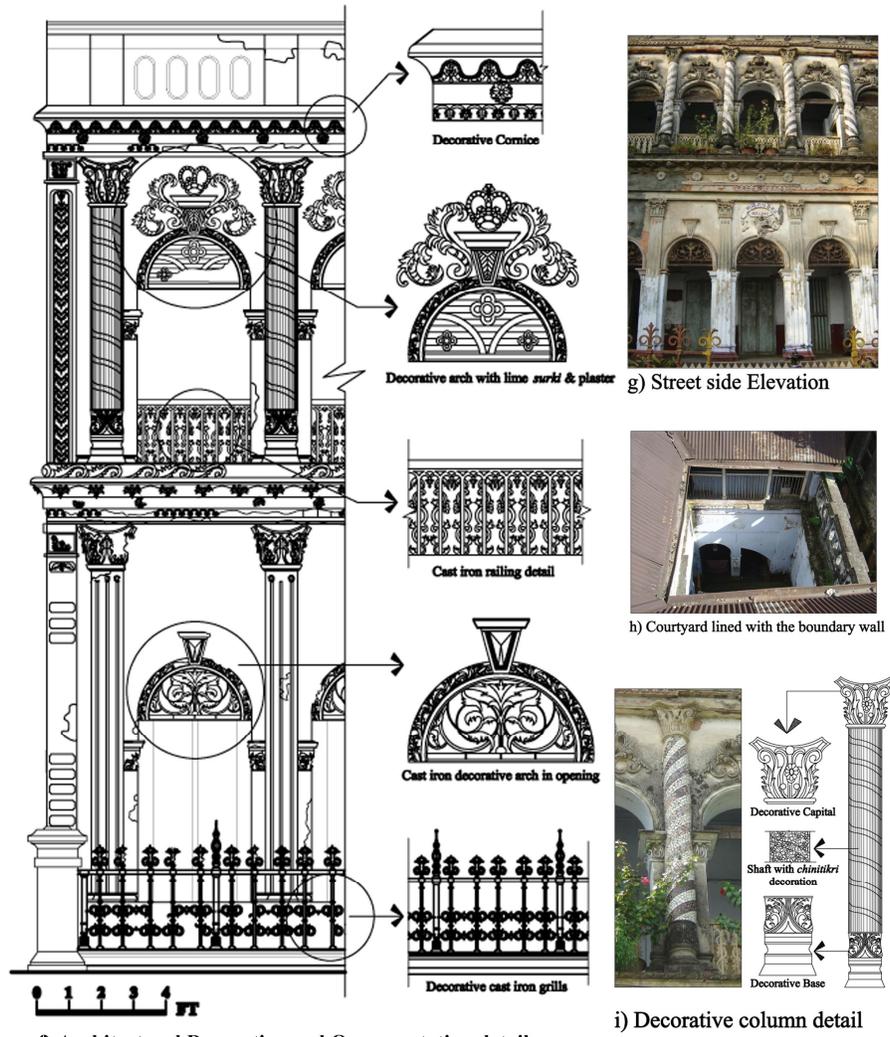
f) Architectural Decorative and Ornamentation details

i) Decorative column detail

Figure-10: f) Architectural Decorative & Ornamentation details, g) Street side view, h) Courtyard lined with the boundary wall, and i) Decorative column detail of the Building no. - 38.

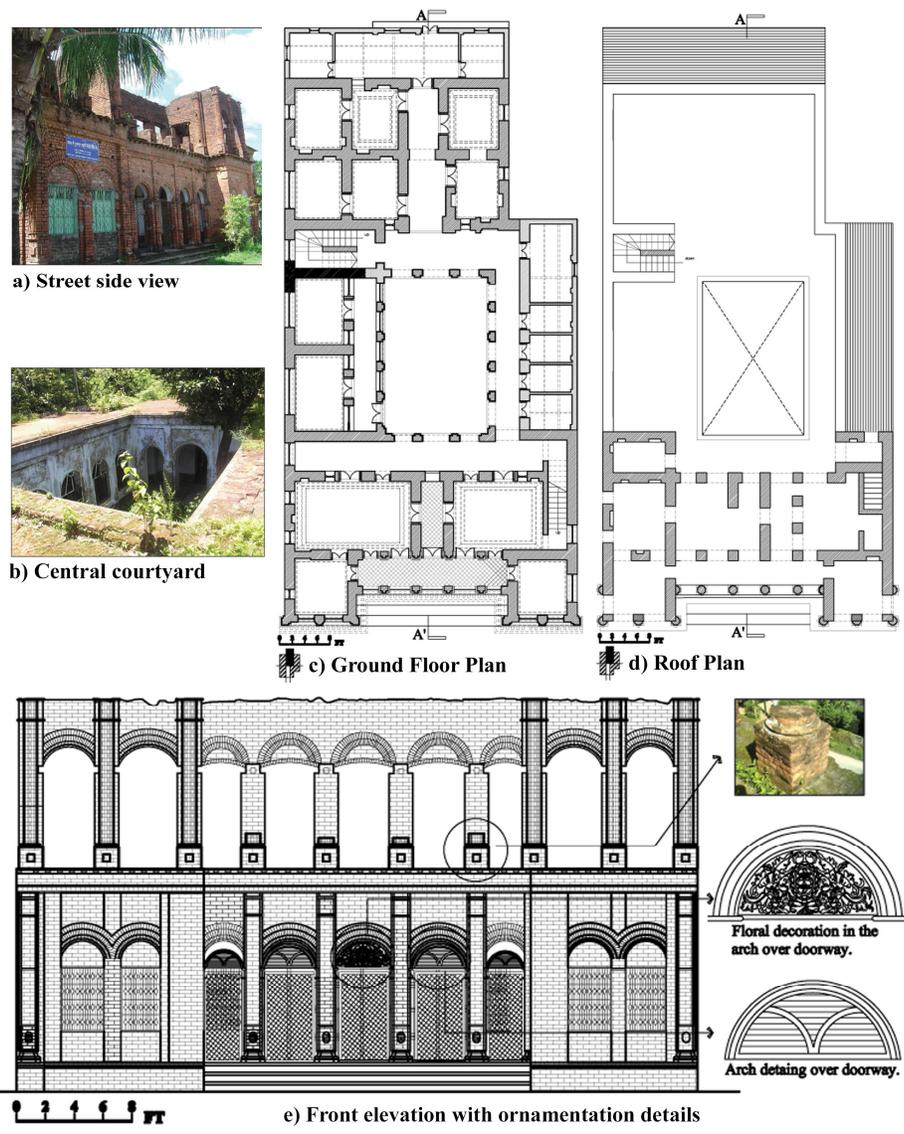
Figure-11: a) Street side view, b) Central Courtyard, c) Ground Floor Plan, d) Roof Plan, and e) Front Elevation with ornamentation details of the Building no. - 40.

| Characteristics of the building | View or Image | Description |
|---|---|---|
| 1. Building type | Fig-11. a,b,c,d | This building is a true example of a central courtyard type building. |
| 2. Building layout | Fig-11. c, d | Rectangular in shape and elongated in the north-south direction. The width and length of the building facade is approximately 14m and 30m respectively. |
| 3. Structure and Materials | Fig-11, Fig-12 | Bricks are entirely left exposed for facade delineation. Cast iron ventilators, window grills, railings had been used. Ornamentation was done by lime <i>surki</i> and plaster in the arch opening. |
| 4. Architectural Decoration and Ornamentation | Fig-11, Fig-12 | The central part with five bay openings is flanked on two sides. Among two types of column systems; one is rectangular column with molded base on the ground floor and the other is round column with rectangular base on the upper floor. Two rectangular corner rooms flanking both sides of the entry and series of colonnaded arches create a harmonious composition. |
| 5. Entrance | Fig-11, a, e | This building has a well-emphasized entry, which did not use any projected entrance portico for the purpose. |

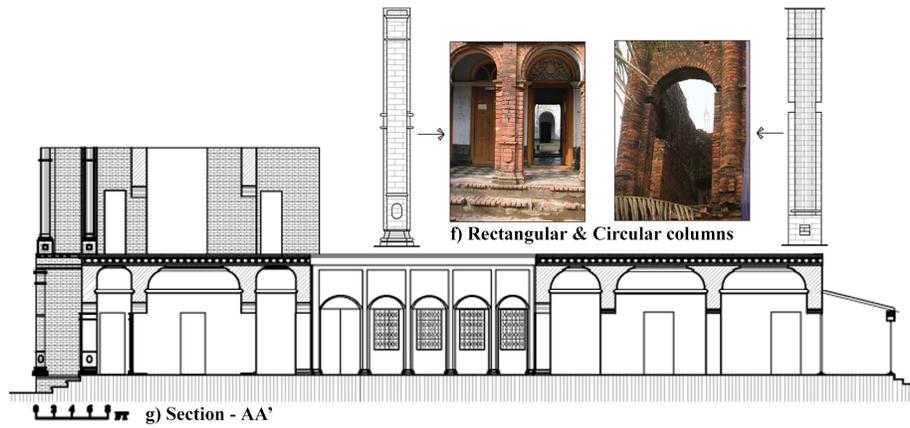
Figure-12: f) Rectangular and Circular Columns, and g) Section-AA' of the Building no. - 40.
 (Source: Field Study, in 2006 and prepared by the author)

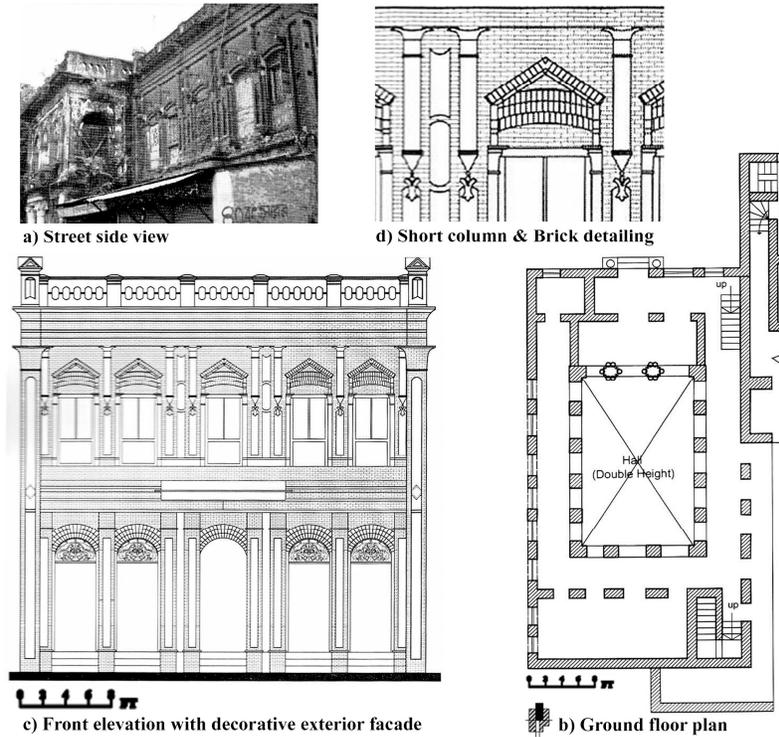
Figure-13: a) Street side view, b) Ground floor plan, c) Front elevation, and d) Short column & Brick detailing of the Building no. - 01.
 (Source: Field Study, in 2006 and prepared by the author)

| Characteristics of the building | View or Image | Description |
|---|---|---|
| 1. Building type | Fig-13. a, b | This is a central hall type building; which is generated with a double height covered hall room. |
| 2. Building layout | Fig-13.b | Rectangular in shape and elongated in the north-south direction. Central hall is located on the ground floor. |
| 3. Structure and Materials | Fig-13 | Bricks are entirely left exposed for facade delineation with different sizes, shapes and layout patterns are used to curve out rich moldings and other designs. Bricks are also arranged over the window lintel. The mortar color of the exposed brick facade is red, laid plain. Cast iron ventilators, window grills, railings had been used. |
| 4. Architectural Decoration and Ornamentation | Fig-13 | Interior columns of the hall have Corinthian capitals, but compound piers are combined with such capitals in front of the <i>bedi</i> . The surface of the columns is covered with <i>chinitikri</i> floral decoration. The parapet, window size, pilaster and the corner treatment which together provide a symmetrical facade with five openings at each level. |
| 5. Entrance | Fig-13.c | On the ground floor there was a short projected entrance portico with pair of round columns on both sides. |

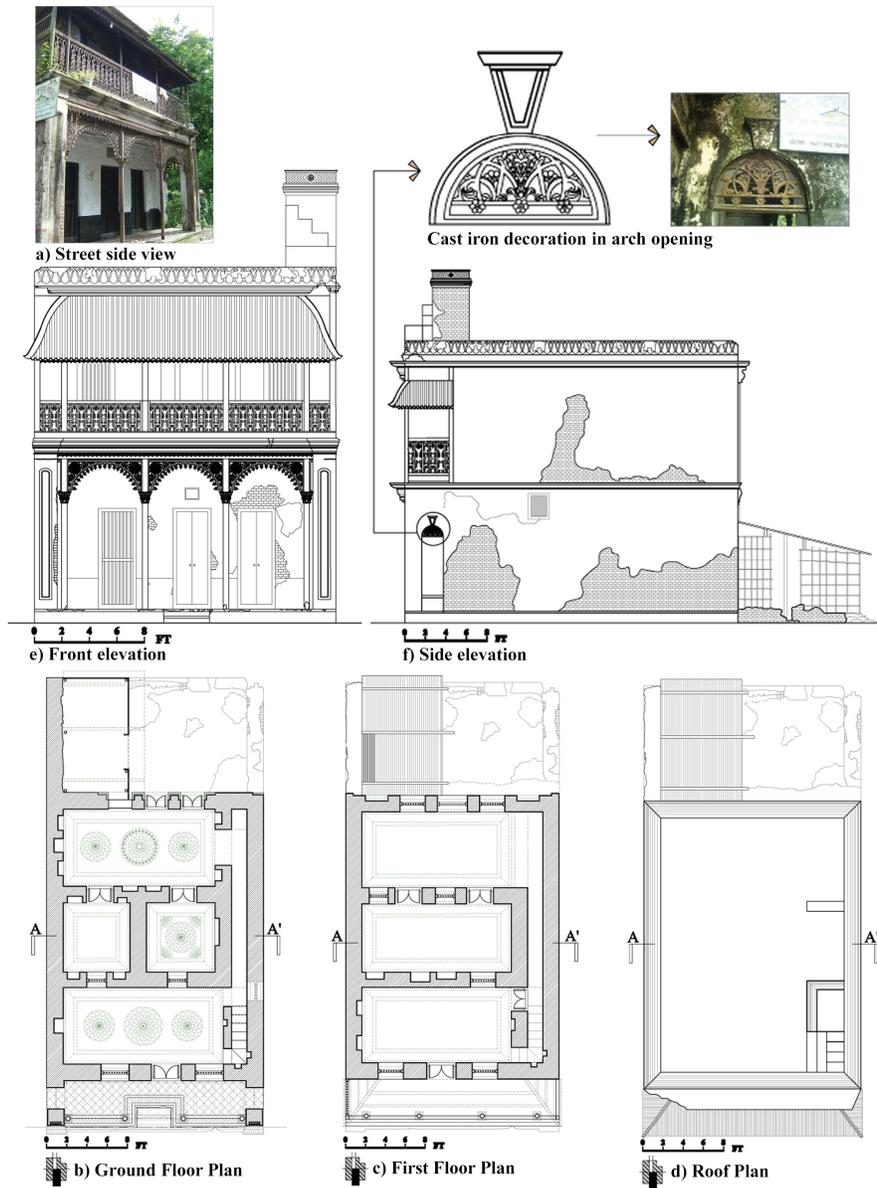
Figure-14: a) Street side view, b) Ground floor plan, c) First floor plan, d) Roof plan, e) Front elevation, and f) Side elevation of the Building no. - 31.

| Characteristics of the building | View or Image | Description |
|---|---|--|
| 1. Building type | Fig-14. a,b,c,d | This is a building of consolidated type; which is generated without any inner court or hall. |
| 2. Building layout | Fig-14. b, c, d | Rectangular in shape and elongated in the north-south direction. The width and length of the building facade is approximately 5.6m and 13.8m respectively. |
| 3. Structure and Materials | Fig-14, Fig-15 | Bricks are plastered for facade delineation. Cast iron columns extended to the upper level were used in front of the entrance verandah. Cast iron brackets, ventilators, window grills, railings, balusters had been extensively used. Roof stands on rafter and purlin made of wood in this house. On the top of upper level verandah, corrugated sheets were placed sloping down towards the road. Colored tiles were used on the floor after the entrance verandah. |
| 4. Architectural Decoration and Ornamentation | Fig-14, Fig-15 | A repetition of the decorative elements borrowed from the previous period buildings can be seen. Round cast iron poles are connected with cast iron arch that used intricate and elaborate floral pattern. |

| 5. Entrance | Fig-14. a, e | This building is designed with an entrance verandah as transition space from street to inner house. |

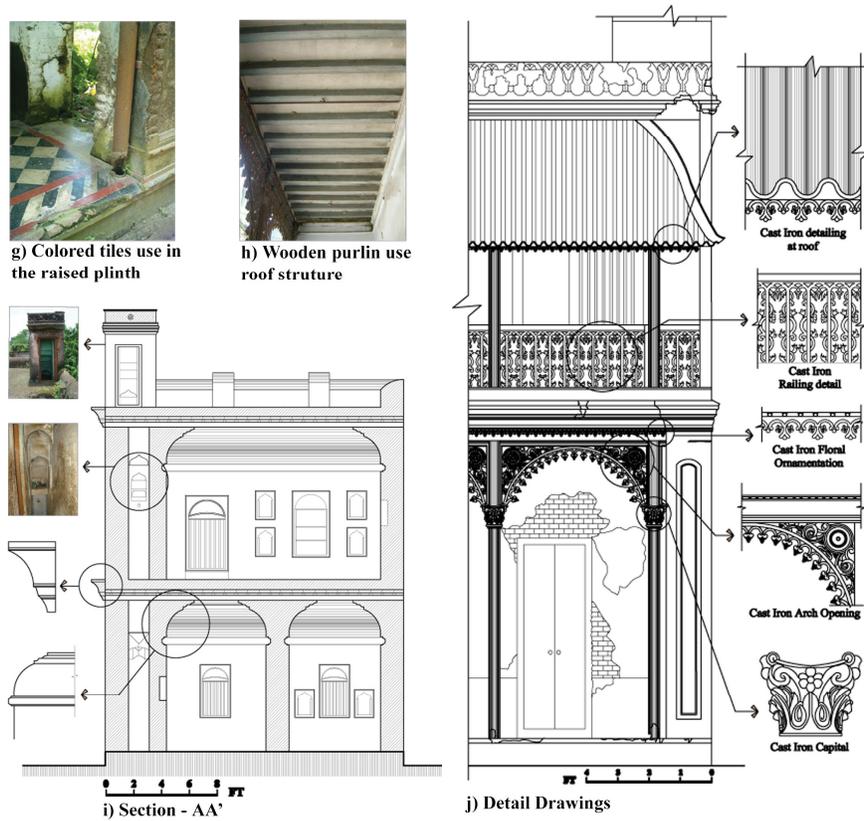
Figure-15: g) Colored tiles in plinth, h) Wooden purlin, i) Section-AA', and j) Detail Drawings of Building no. - 31; (Source: Field Study, in 2006 and prepared by the author)

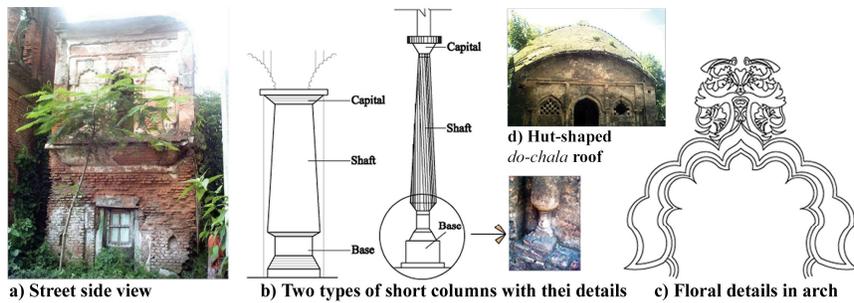
Figure-16: a) Street side view, b) Two types of short column, c) Floral details in arch, and d) Do-chala roof of the building no. - 42; (Source: Field Study, in 2006 and prepared by the author)

| Characteristics of the building | View or Image | Description |
|---|---|--|
| 1. Building type | Fig-16.a Fig-17. e, f, g | This is a building of multiple compartment type; where lower floor of this building consists of three rooms placed one after another. The upper floor has an open court located at the center of the spatial planning used as a forecourt to the temple. |
| 3. Structure and Materials | Fig-16, Fig-17 | Bricks are plastered for facade delineation. The hut-shaped <i>do-chala</i> structure used on rooftop in part of this building. This part with the pitch roof was used as a <i>mandir</i> – a place of worship by the Hindus. Here architectural and ornamental features, various sculptural details and moldings done with plaster in lime mortar. |
| 4. Architectural Decoration and Ornamentation | Fig-16, Fig-17 | The hut-shaped <i>do-chala</i> rooftop of this building is an elegant feature taken from Mughal ornamentation and style. Also in this building; use of short column, various sculptural details and moldings, well proportioned multiple cusps decorations over the openings were borrowed from late-Mughal period. The openings are flanked by short columns. In this building the use of blind arches is being noticeable. |
| 5. Entrance | Fig-16.a Fig-17.h | This building is designed with a direct entrance which has a formal balanced decorative exterior facade. |

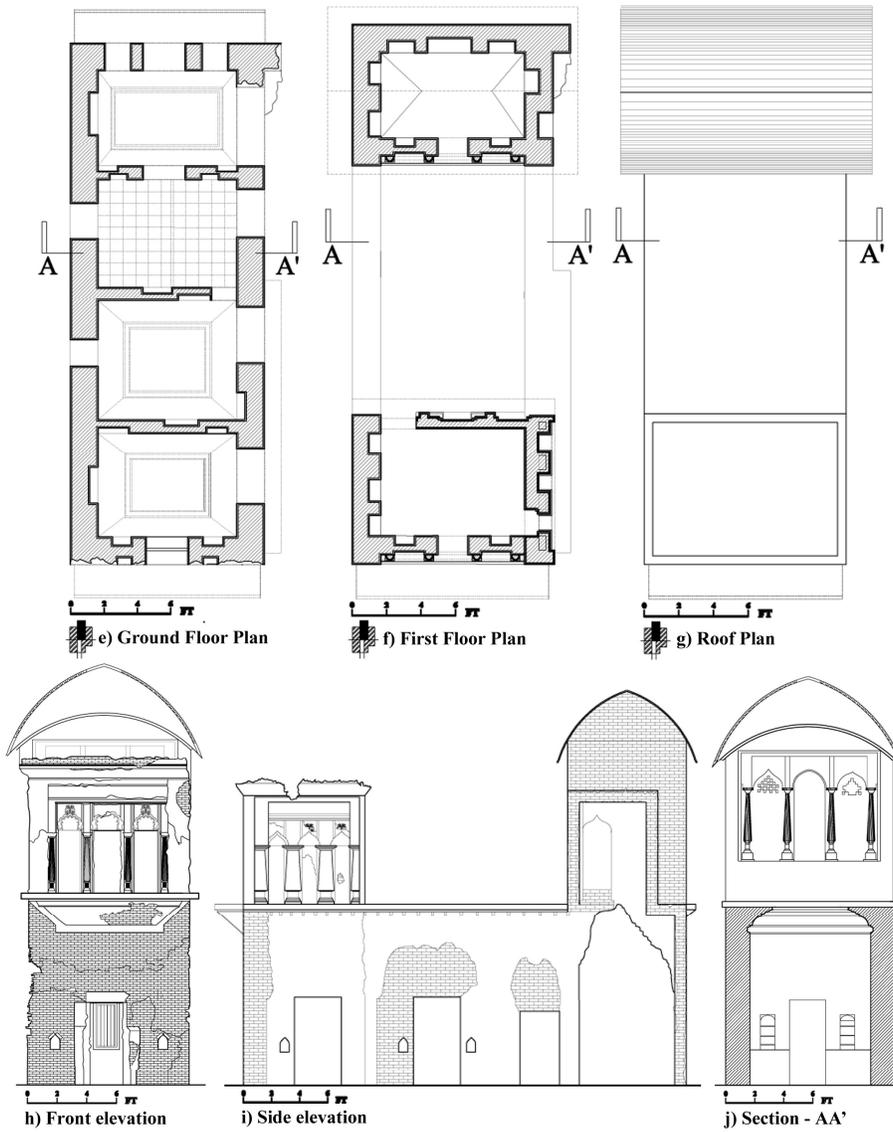
Figure-17: e) Ground floor plan, f) First floor plan, g) Roof plan, h) Front elevation, i) Side elevation, and j) Section-AA' of the building no. - 42.
(Source: Field Study, in 2006 and prepared by the author)

| Characteristics of the building | View or Image | Description |
|---|---|--|
| 2. Building layout | Fig-17. e, f, g | Rectangular in shape and elongated in the north-south direction. The width and length of the building facade is approximately 3.7m and 10.2m respectively. |
